# ANNUAL REPORT FOR 2015

**UT to Cane River Site #12 Mitigation Site**  
**Yancey County**  
**TIP No. R-2518B**  
**COE Action ID: SAW-2007-2197-357/300**  
**DWR #: 20071134**

Prepared By:  
Natural Environment Section & Roadside Environmental Unit  
North Carolina Department of Transportation  
November 2015

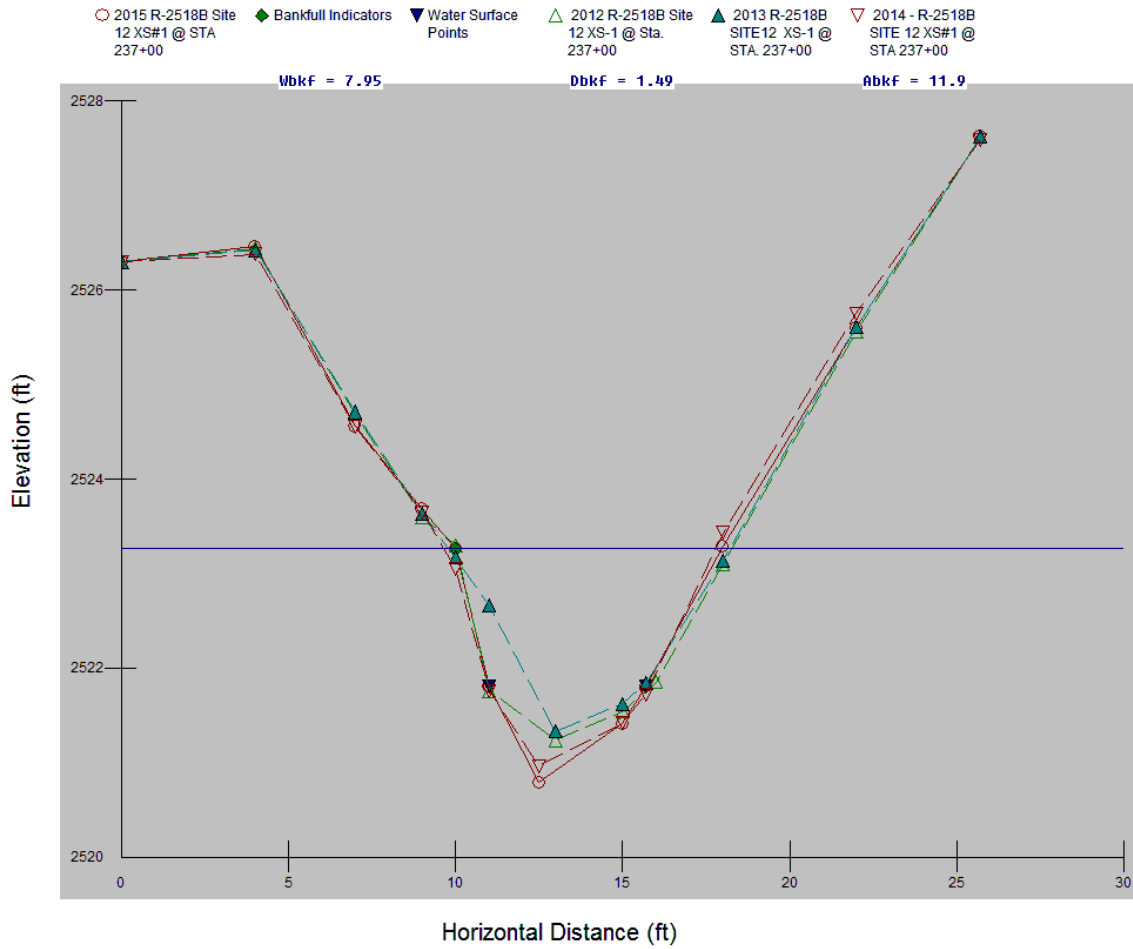
# R-2518B Site 12 XS#1 @ STA 237+00

Site #12: Cross-Section #1 (Pool) Abbreviated Morphological Summary					
	2012	2013	2014	2015	2016
Bankfull Cross Sectional Area (ft <sup>2</sup> )	11.48	8.57	10.06	11.88	
Maximum Bankfull Depth (ft.)	2.06	1.84	2.09	2.47	
Bankfull Mean Depth (ft.)	1.38	1.06	1.34	1.49	
Bankfull Width (ft.)	8.33	8.05	7.49	7.95

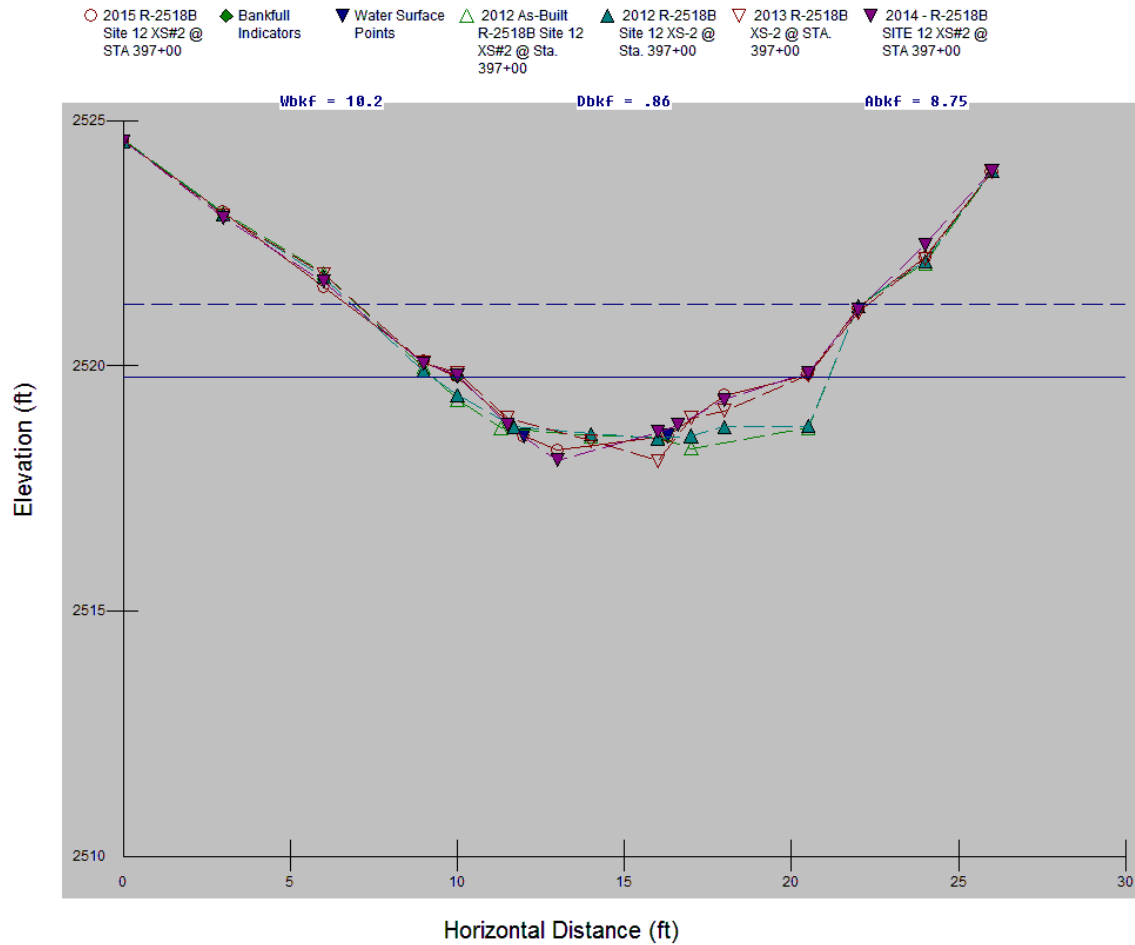
## R-2518B Site 12 XS#2 @ STA 397+00

Site #12: Cross-Section #2 (Riffle) Abbreviated Morphological Summary					
	2012	2013	2014	2015	2016
Bankfull Cross Sectional Area (ft <sup>2</sup> )	7.2	9.95	9.47	8.75	
Maximum Bankfull Depth (ft.)	0.88	1.79	1.74	1.49	
Width of the Floodprone Area (ft.)	13.03	16.64	16.34	15.49	
Bankfull Mean Depth (ft.)	0.66	0.94	0.92	0.86	
Width/Depth Ratio	16.5	11.22	11.16	11.87	
Entrenchment Ratio	1.2	1.58	1.59	1.52	
Bankfull Width (ft.)	10.89	10.55	10.27	10.21

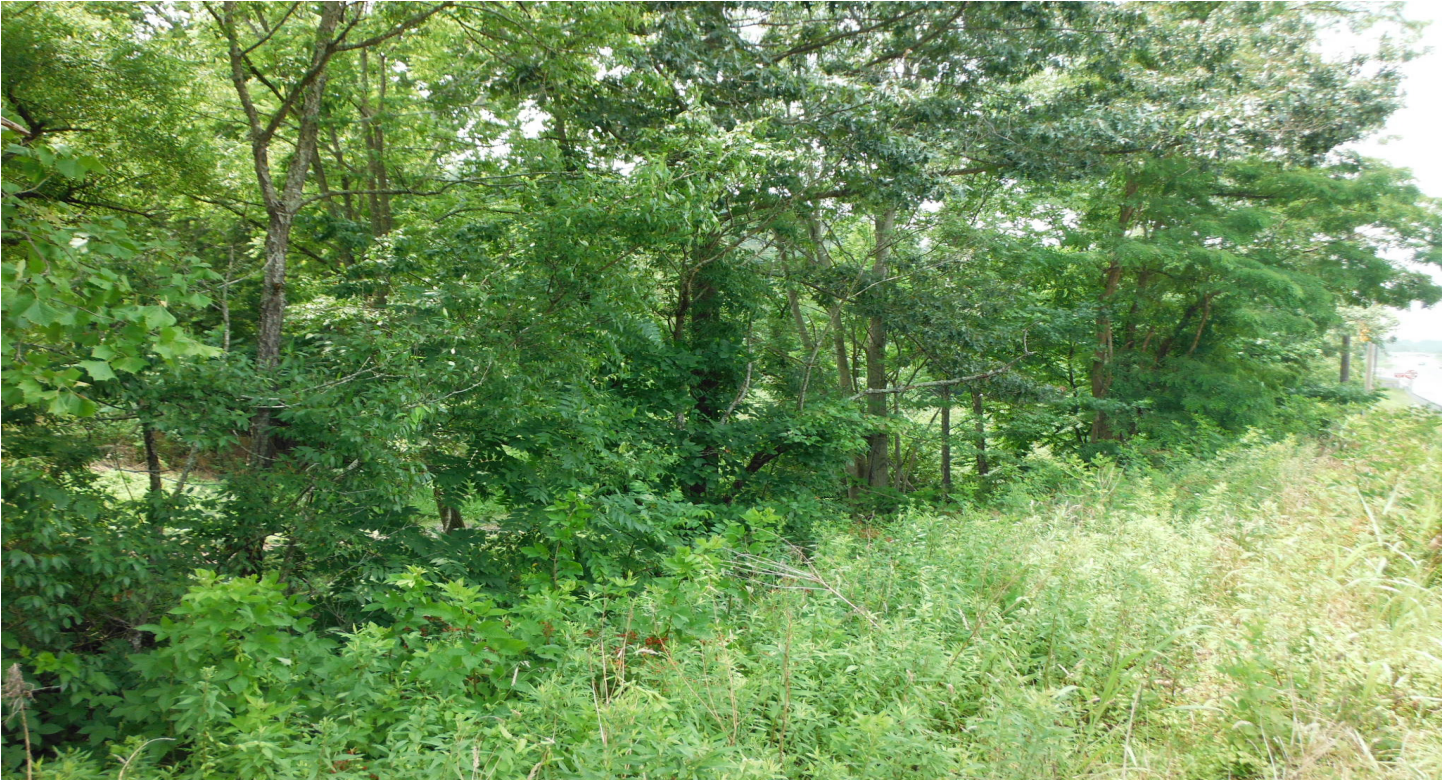
Vegetation Overview Photo (North Buffer)

**Streambank & Buffer Vegetation:** The streambank reforestation was completed in March and April 2012. The Year 4 vegetation monitoring evaluation noted: Type I: Black Willow, Silky Dogwood and Type II: Green Ash were surviving at the time of the monitoring evaluation. The existing vegetation is already providing a canopy of hardwood vegetation along the reach.
